NIST NCSTAR 2: Vol. I

Report of the Technical Investigation of The Station Nightclub Fire

June 2005

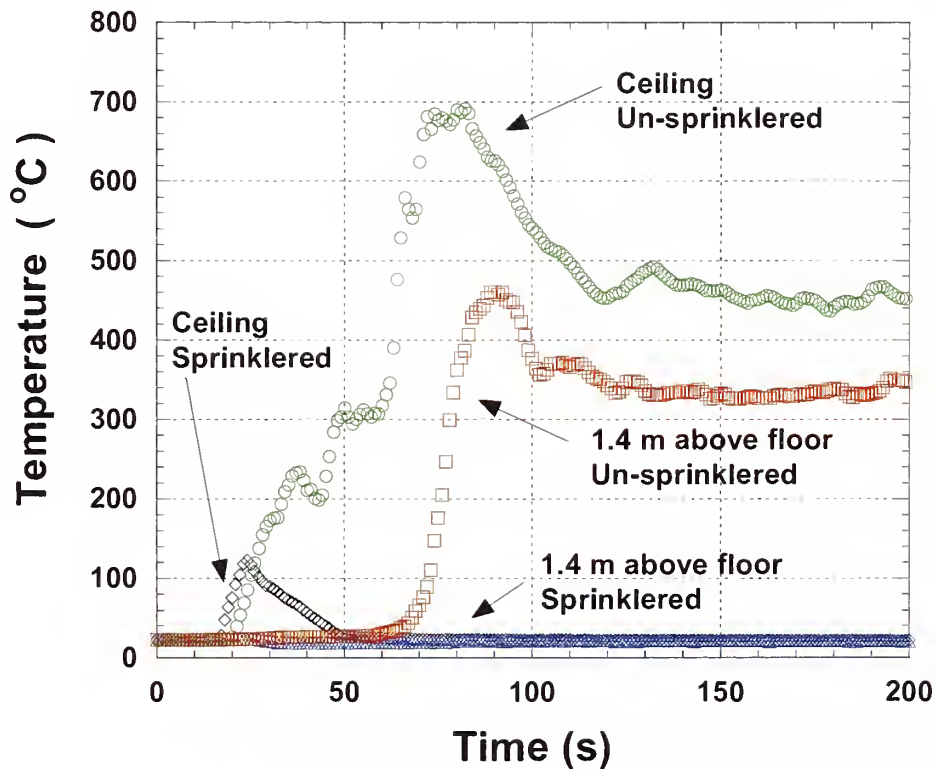
The comparison between the temperatures at the ceiling and 1.4 m above the floor for the sprinklered and unsprinklered experimental data is striking, as demonstrated in Fig. 4-28a for location C and Fig. 4-28b for location D. At 25 seconds, the temperatures at the ceiling were about 175 °C at location C and 125 °C at location D for both experiments, indicative of the fire being properly replicated up to the point when the sprinkler activated. During the next 25 seconds the temperatures throughout the compartment returned to close to ambient conditions in the sprinklered compartment. This compared to a continuing rapid rise in temperatures for the unsprinklered compartment, which reached ceiling temperatures in excess of 300 °C at 50 seconds, and peaks of 700 °C plus in the following 25 seconds. Peak temperatures of 400 °C to 500 °C were reached 1.4 m above the floor for the unsprinklered test; temperatures did not rise at all for the sprinklered compartment at this location.

Figure 4-28b. Temperatures versus Time for Unsprinklered and Sprinklered Mockup Test. Thermocouples positioned on Main Floor (Location D) at ceiling and 1.4 m (4.5 ft) above floor.

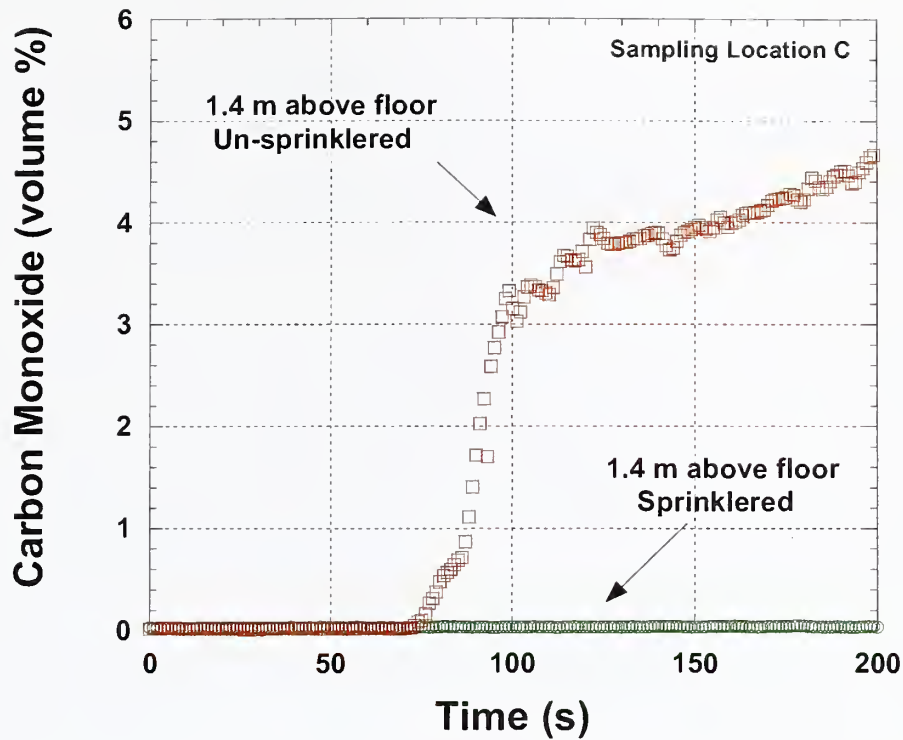
Figure 4-32. Carbon Monoxide Volume Fraction vs Time for Unsprinklered and Sprinklered Mockup Test. Gas Sampling probe positioned on Main Floor (Location C) at 1.4 m (4.5 ft) above floor.

At both locations C and D, volume fractions of carbon monoxide at the 1.4 m elevation did not begin to increase until 70 seconds to 80 seconds after ignition for the unsprinklered mock-up experiments, but then increased to 3 % in the next 20 seconds to 30 seconds and reached 4.5 % by 200 seconds after ignition. During the sprinklered test burns, the carbon monoxide concentration at neither location C nor location D appeared to increase much above ambient levels.

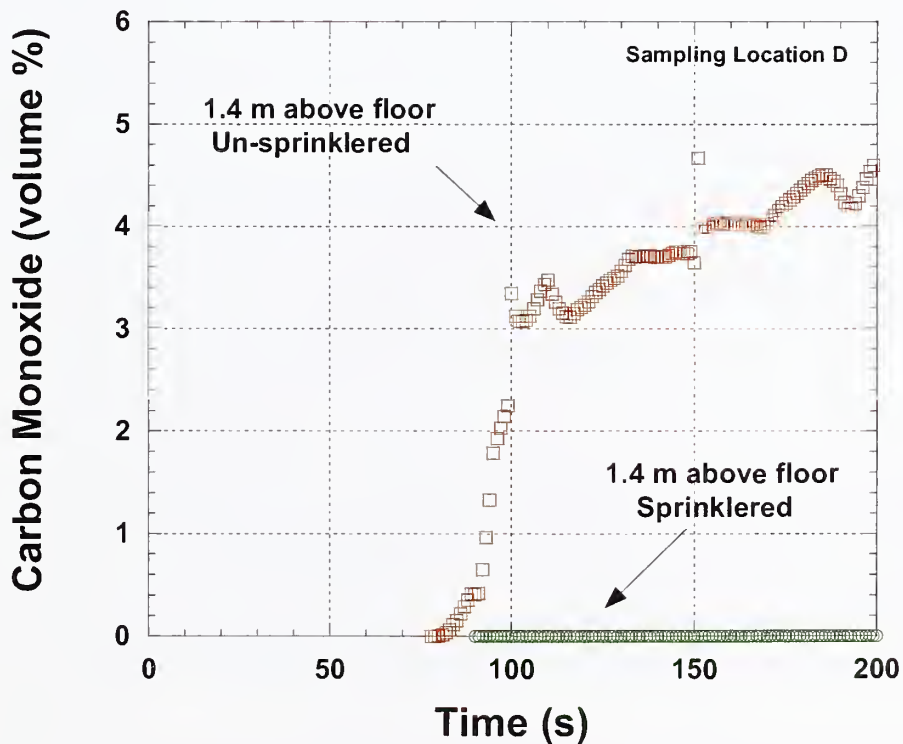
Figure 4-33. Carbon Monoxide Volume Fraction vs Time for Unsprinklered and Sprinklered Mockup Test. Gas Sampling probe positioned on Main Floor (Location D) at 1.4 m (4.5 ft) above floor.

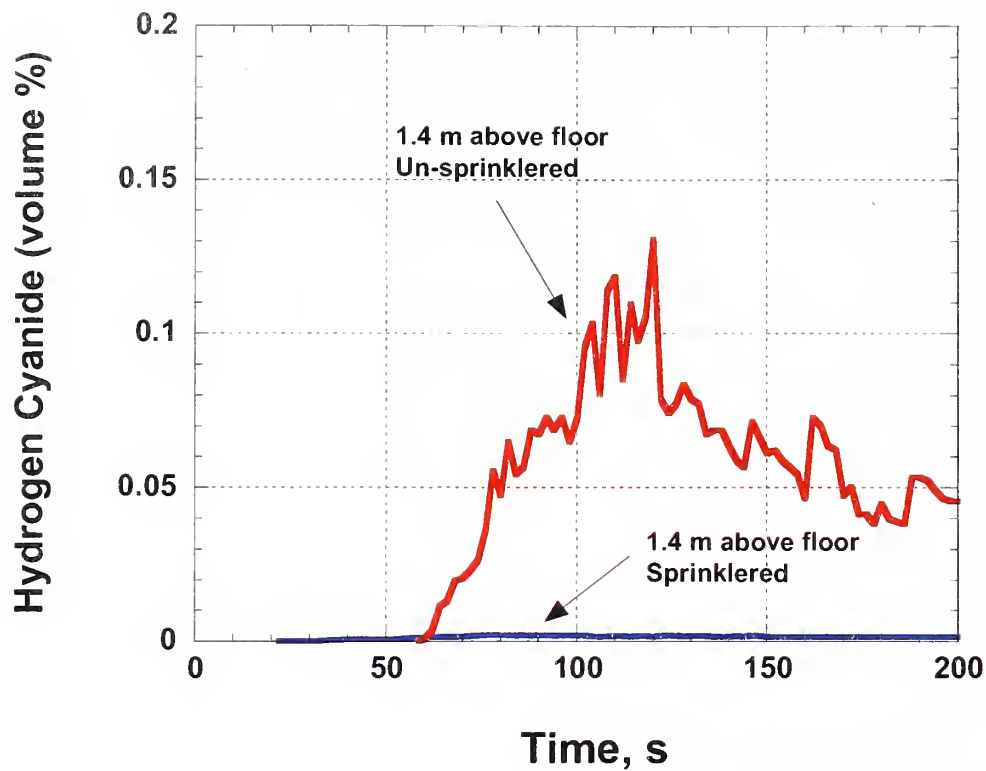
Figure 4-34. Hydrogen Cyanide Volume Fraction vs Time for Unsprinklered and Sprinklered Mockup Test. Gas Sampling probe positioned on Main Floor (Location C) at 1.4 m (4.5 ft) above floor.

The volume fractions of hydrogen cyanide at the 1.4 m elevation began to increase 60 seconds after ignition for the unsprinklered mockup experiments. At location C, the HCN reached its peak value of 0.13 % in 120 seconds. The HCN increased slightly faster at location D, where it reached a peak volume fraction of 0.17 % in about 90 s. During the sprinklered test burns, the hydrogen cyanide concentration at locations C and D were barely above the measurable limit.

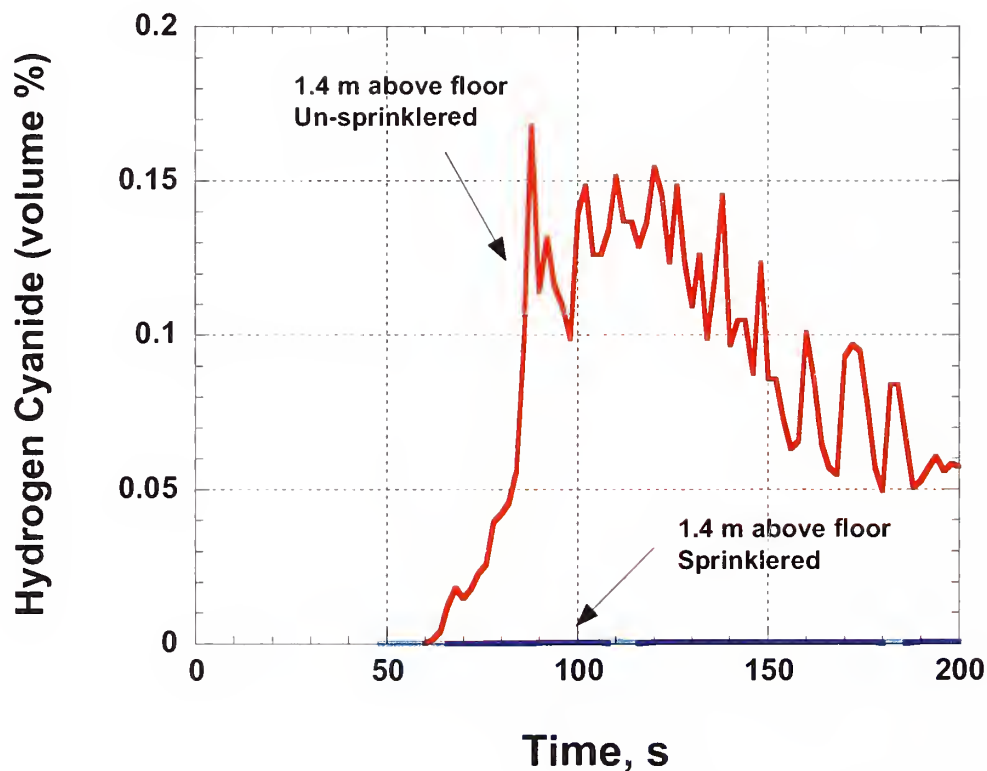
Figure 4-35. Hydrogen Cyanide Volume Fraction vs Time for Unsprinklered and Sprinklered Mockup Test. Gas Sampling probe positioned on Main Floor (Location D) at 1.4 m (4.5 ft) above floor.

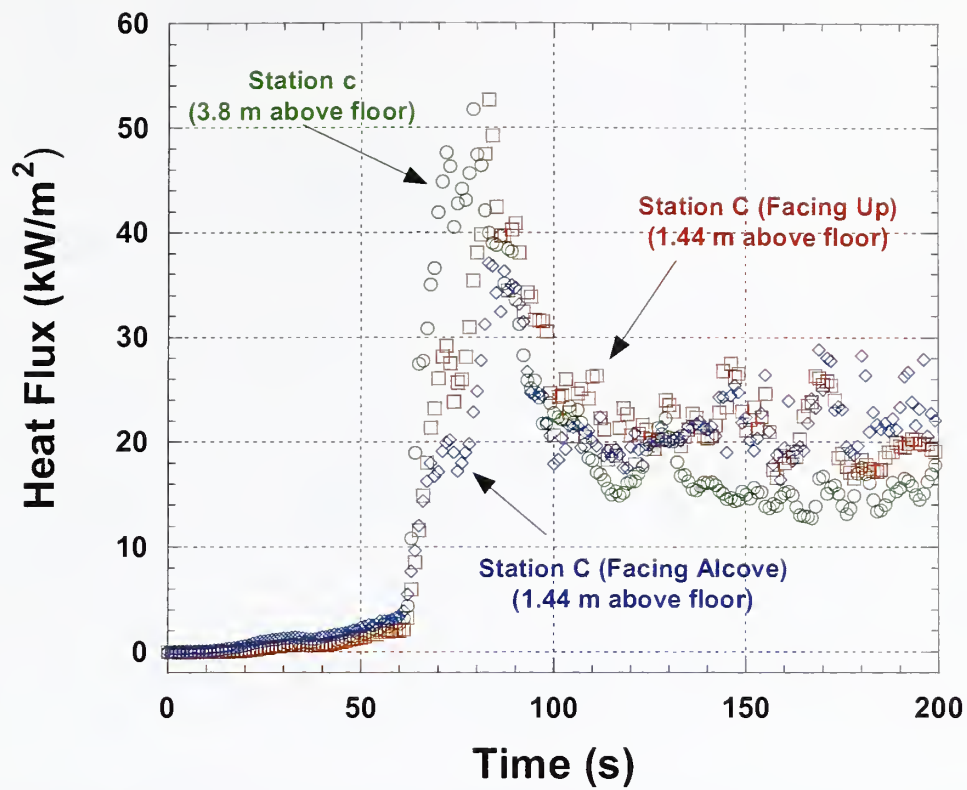
Figure 4- 37. Heat Fluxes versus time for unsprinklered mockup test. Radiometer positioned flush with ceiling (3.8 m above floor); heat flux gauges facing up (1.44 m above floor), and facing alcove (1.44 m above floor) at sampling location C.

For the unsprinklered compartment test, the output of the thermal radiation and total heat fluxes for the radiometer and heat flux gauges at locations C and D are shown in Fig. 4-37 and Fig 4-38. At location C, peak fluxes in excess of 50 kW/m² were reached about 70 seconds after ignition. Peak fluxes at location D were about 20 % lower than location C. At 100 seconds after ignition, radiation and heat flux at

location C and the heat flux at location D decreased significantly to 20 kW/m^2 and appeared to remain relatively constant at both locations. The radiometer in the ceiling at location D dropped to 10 kW/m^2 before becoming relatively steady. (Additional plots of heat flux are shown and discussed in App. G.)

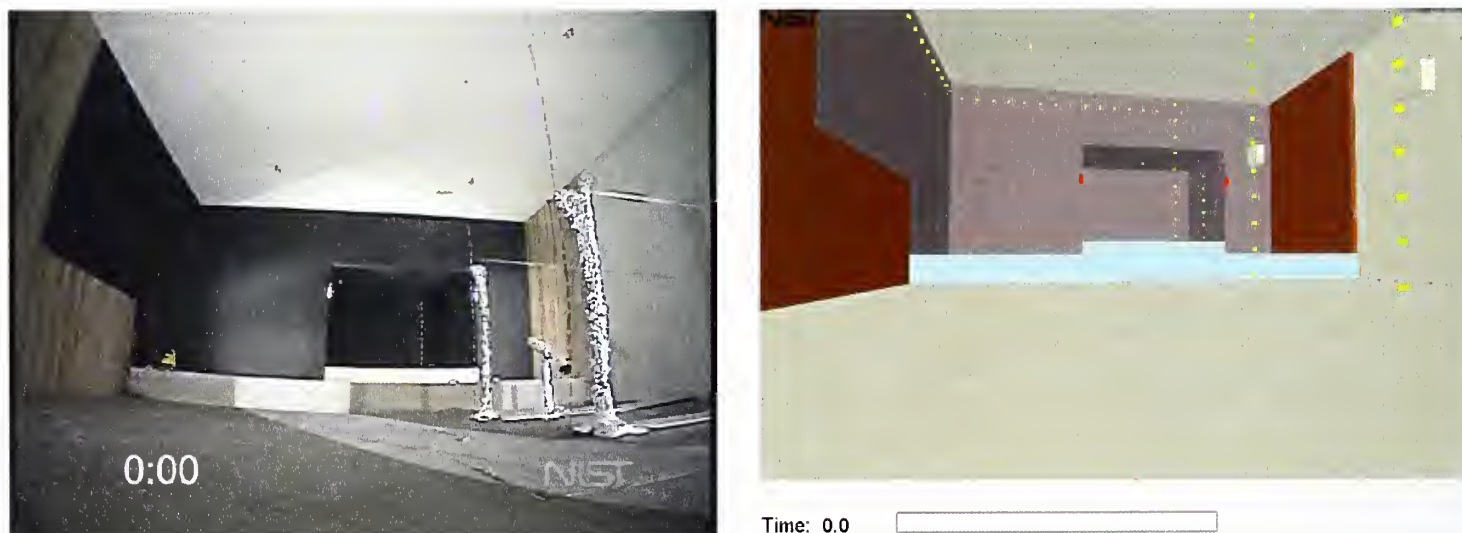
Figure 5-2. Ignition at the corners of the drummer's alcove, $t = 0$ second.

Figure 5-2 shows the experiment and the simulation at the time of ignition. The video frame on the left shows the foam covered walls, the wood paneling, and the carpeted platform. Gypsum board covered the ceiling, floor and the remaining wall areas that were not covered with wood paneling or foam. Some of the instrumentation can be seen in the foreground of the video frame. In the image from the simulation, on the right, the comparable interior finishes can be seen. The instrumentation in the right figures is represented by colored dots. The thermocouples appear as yellow dots in evenly spaced arrays. The light gray blocks represent the locations of the heat flux sensors and the gas sampling locations, which were installed at approximately 1.5 m (5 ft) above the floor.

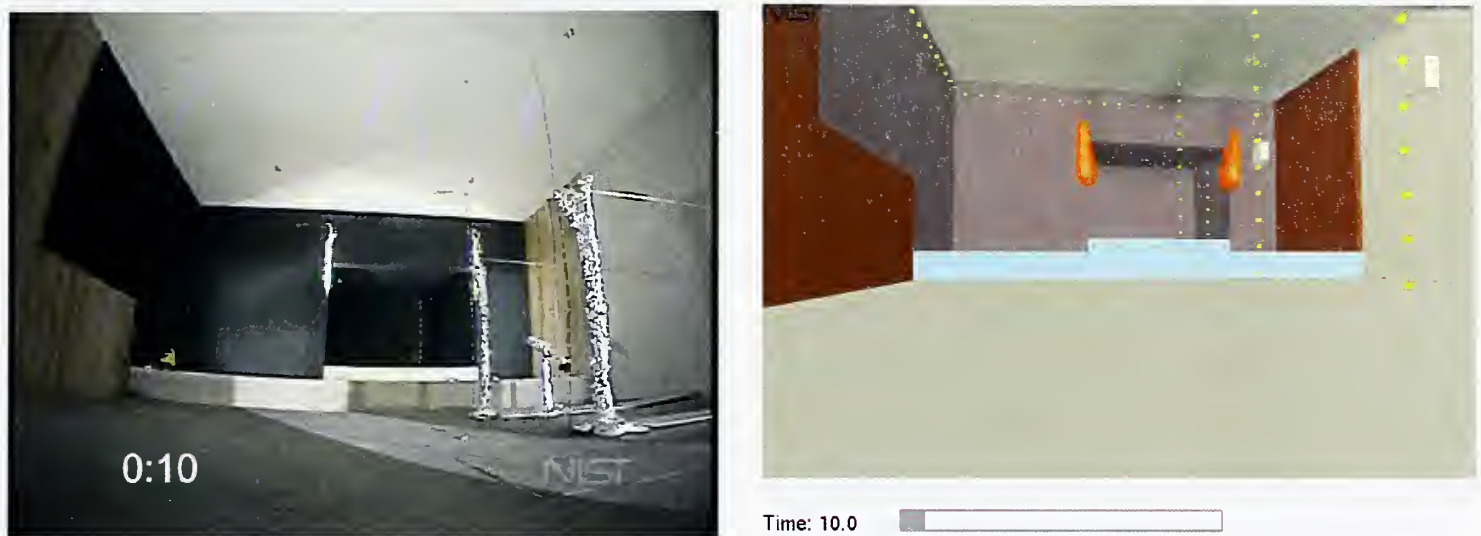
Figure 5-3. Flames spreading toward ceiling, $t = 10$ seconds after ignition.

Figure 5-3 compares the fire development at 10 seconds after ignition. A flame is shown on both corners where the platform wall intersects with the drummer's alcove. In the case of FDS, the area that appears to be involved with flames is based on the stoichiometric mixture fraction, where there is the ideal mixture of fuel and oxygen for a robust flame to exist. The heat release rate per unit volume represented by the simulated flames is 285.5 kW/m^3 . The flames in the simulation appear wider due to the grid resolution, which is 100 mm (4 in) throughout the room.

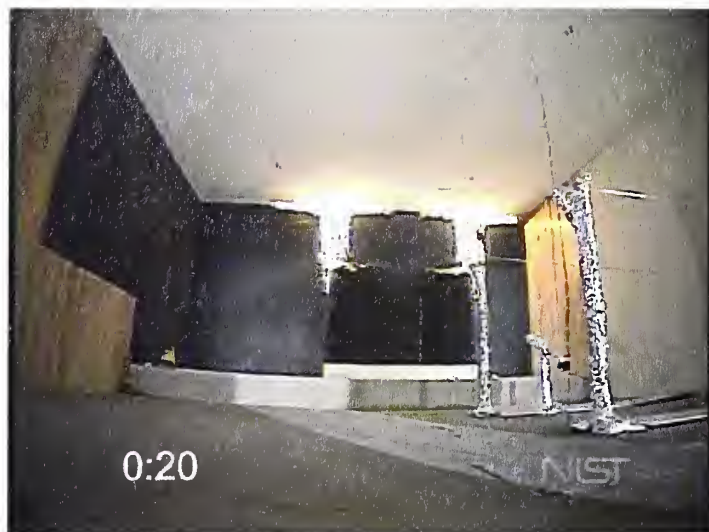
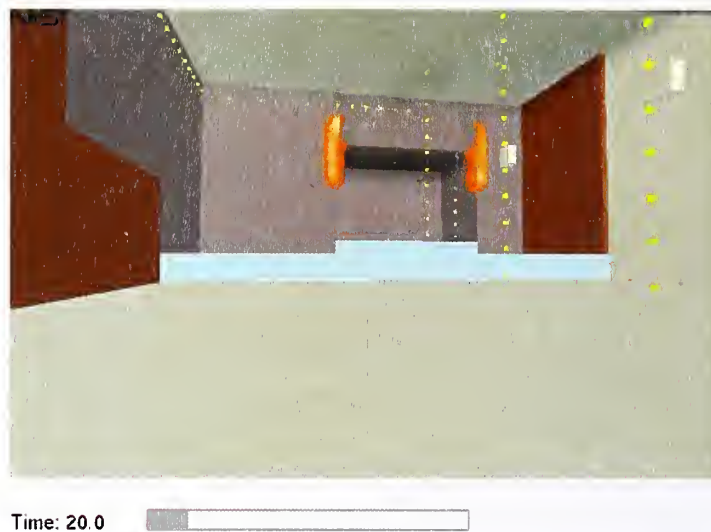
Figure 5-4. Flames impinging on ceiling, $t = 20$ seconds after ignition.

The video frame to the left in Figure 5-4 shows flames 20 seconds after ignition growing vertically and impinging on the ceiling. The simulated flames on the right, however, have not yet reached the ceiling. As noted above, the simulated flame is constrained to grow in 100 mm (4 in) increments, both vertically and laterally. This may account for the wider flame and the accompanying redistribution of energy that would reduce the propensity for rapid vertical flame spread. Light smoke can be seen in both images along the ceiling of the alcove, with light wisps of smoke along the ceiling above the platform.

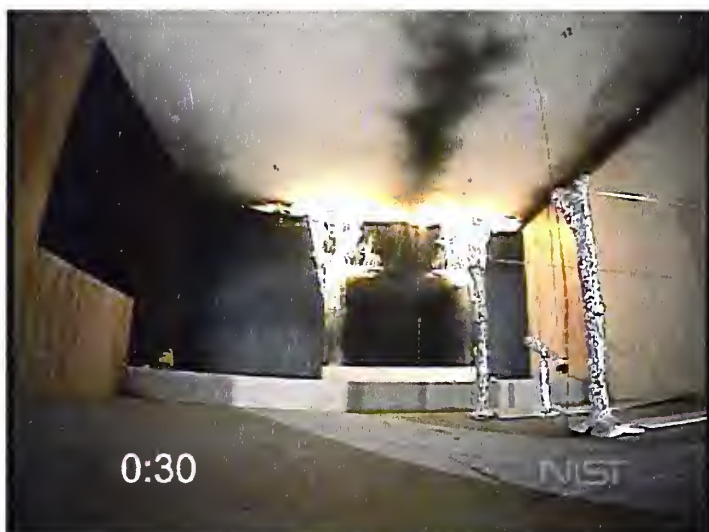
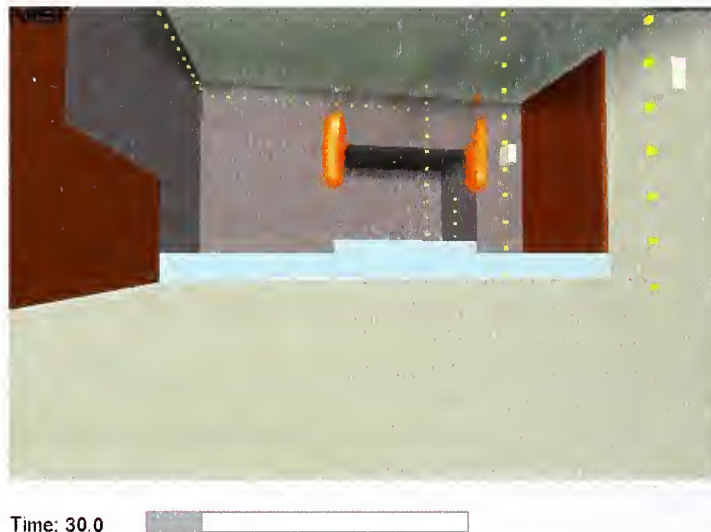
Figure 5-5. Visible smoke spreading across ceiling, $t = 30$ seconds after ignition.

Figure 5-5 shows an increased amount of smoke flow across the ceiling at 30 seconds after ignition. The actual fire continues to grow at a faster rate than the simulated flames. In the video frame on the left the flames have formed twin V-patterns on each side of the alcove and the flames are spreading across the alcove ceiling. Notice the light smoke that is coming up from the carpeting below the two fire plumes. This is the result of foam melting and the burning foam droplets falling to the floor. This mode of flame spread is not accounted for within the FDS model. At 40 seconds after ignition, the video frame in Figure 5-6 shows areas of the foam on the platform wall have burned out (note the dark area directly above the point of ignition on the left side of the alcove). The actual flame fronts have continued to spread and into the alcove, where fire is visible on portions of the side walls and the ceiling of the alcove. The flames simulated with FDS have also grown, although at a slower rate. Both of the simulated flames have impinged on the ceiling.

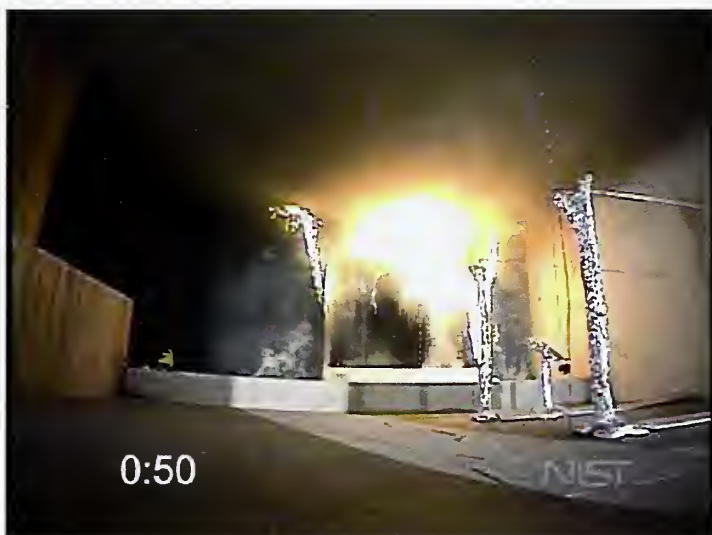
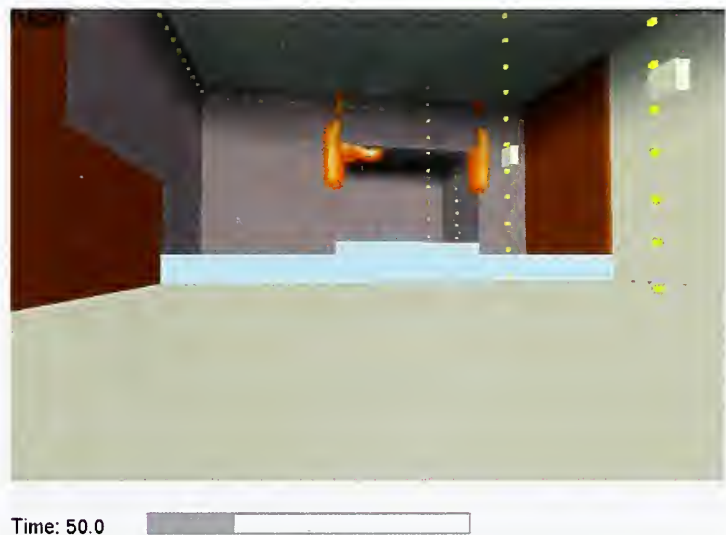
Figure 5-7. Ceiling of alcove fully involved in fire, t = 50 seconds after ignition.

Figure 5-7, has images captured at 50 seconds after ignition. In the experiment, it appears that the entire ceiling of the alcove is burning, as well as the area of the platform wall above the opening to the alcove. There is also more smoke from drop-down of the burning foam onto the carpet, both in the alcove and on the platform. In the simulation, the flames have moved into the alcove and are spreading across the ceiling. In both images, the smoke or hot gas layer has developed across the ceiling of the enclosure.

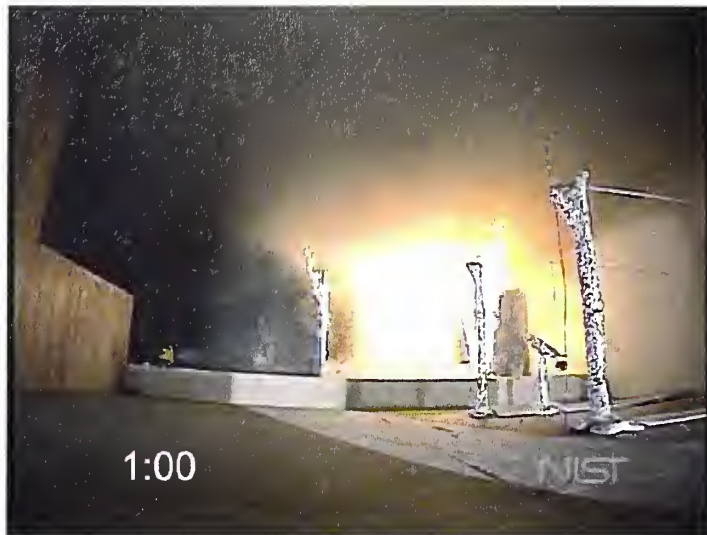
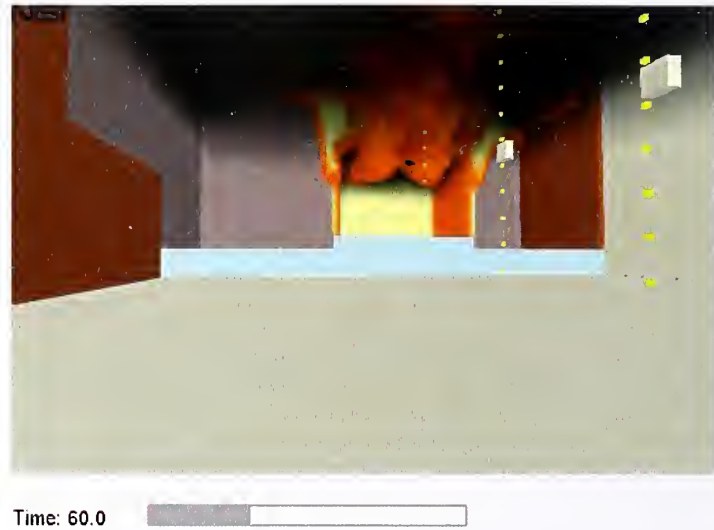
Figure 5-8. Flashover has occurred in alcove area, $t = 60$ seconds after ignition.

In Figure 5-8, the ceiling and the walls of the alcove have become fully involved with fire in both of the images. At 60 seconds after ignition, flashover has already occurred in the experiment and flashover is about to occur in the simulation. In both cases, flames are extending out of the alcove across the ceiling and the smoke layer has become thicker and darker.

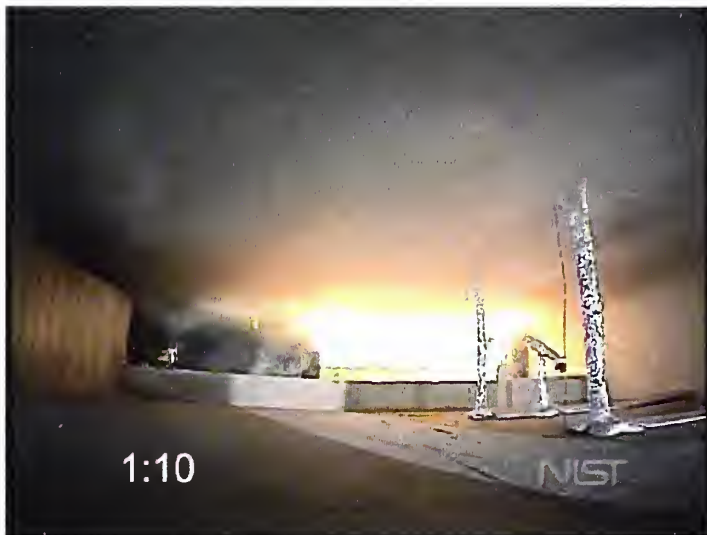
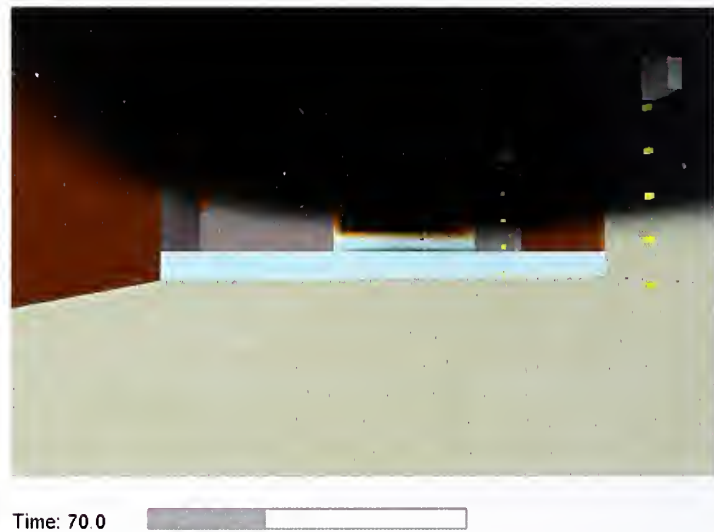
Figure 5-9. Smoke layer has dropped to 1.5 m above floor, $t = 70$ seconds after ignition.

The images in Figure 5-9 show a significant increase in the amount of the smoke in the enclosure. The smoke layer has descended to within 1.5 m (5 ft) of the floor. The flames have spread along the wall behind the platform and can be seen at the lower edge of the smoke layer in both the video frame and the image from the simulation. The smoke in the experiment appears lighter in color than it actually is due to light that is being reflected from floor level halogen lights that were used to improve the visibility for the video cameras.

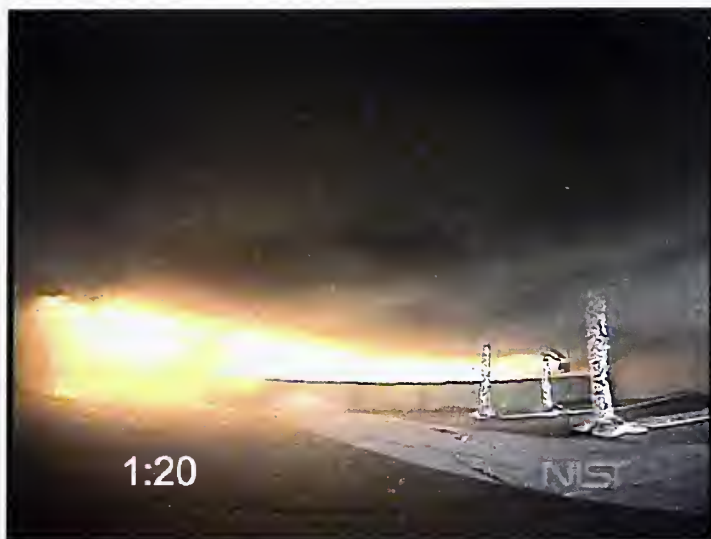
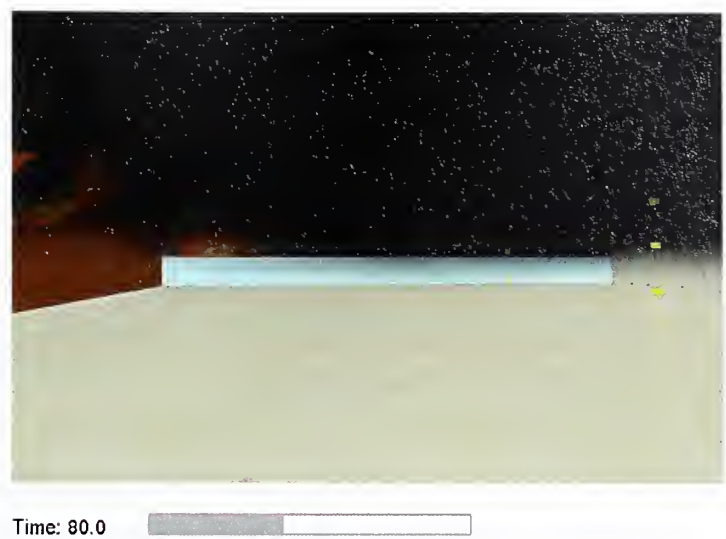
Figure 5-10. Fire continues to spread, t = 80 seconds after ignition.

The fire continues to grow in both the experiment and the simulation as shown in Figure 5-10. The smoke layer has continued to descend. The interface height of the smoke layer is approximately 0.75 m (2.5 ft) above the floor at 80 seconds after ignition for both the experiment and the simulation. Both images also show the flame extension on the left wall of the enclosure. The upper portion of the left wall near the platform had foam installed over the paneling.

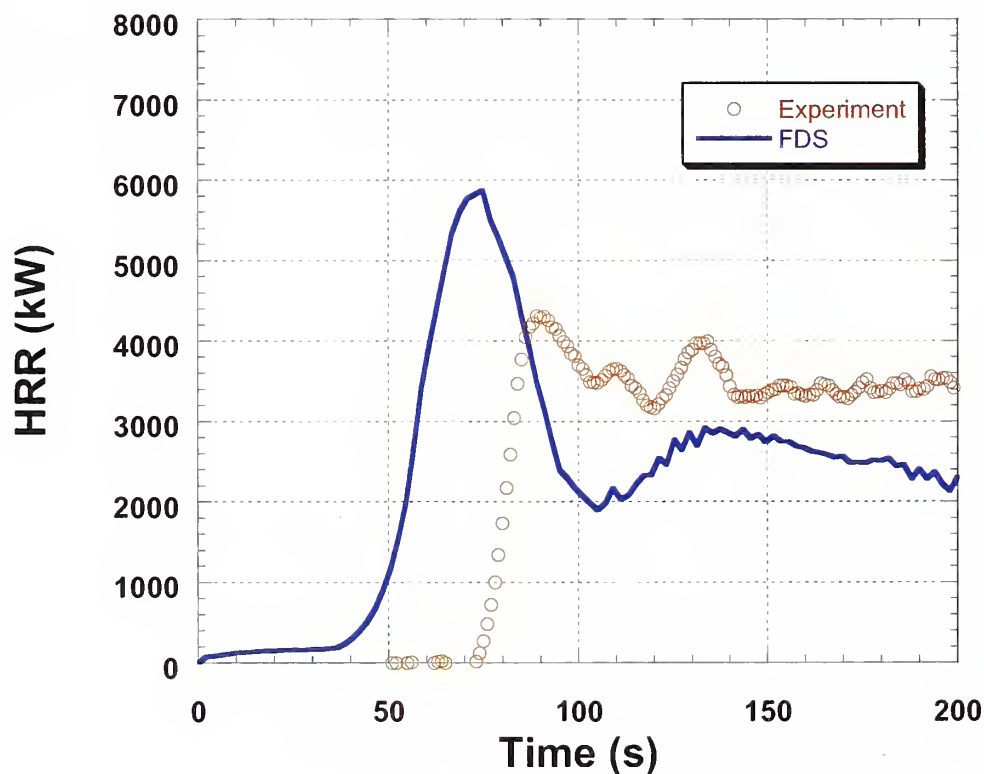
Figure 5-12. Power generated in experiment as measured outside of doorway, compared to FDS simulation of heat release rate from fire within compartment.

Figure 5-12 compares the measured heat release rate leaving the door of the experiment (based upon oxygen consumption) to the heat release rate from the fire within the compartment as predicted by FDS. For fires burning in the open under the laboratory hood, the thermal power measured by the oxygen depletion calorimeter is equal to the heat release rate from the fire. However, for a fire within an enclosure, the effluent from the room is a mixed average of the upper layer gases, and does not represent the instantaneous heat release rate of the fire. Smoke did not exit the compartment doorway until approximately 60 seconds after ignition. This means that a direct comparison between the experimental measurements and the numerical predictions cannot be made because the oxygen depletion calorimeter does not respond to a fire within an enclosure until the combustion products have had time to exit the door and become entrained into the hood. The heat release rate predicted by FDS in Fig. 5-12 represents the instantaneous heat release throughout the room. The heat release rate reaches a peak of

approximately 6 MW about 70 seconds into the simulation, 20 seconds prior to the peak in thermal power measured in the oxygen depletion calorimeter. Both curves approach $3000 \text{ kW} \pm 300 \text{ kW}$ approximately 150 seconds into the fire, again consistent with a ventilation-limited condition. The heat release rates diverge at longer times as the model consumes the remaining interior finish fuels while the physical fire continues to burn at a reduced rate into the wood supporting the platform and walls. When the areas under the heat release rate curves were integrated, the resulting energies were found to agree within 10 %.

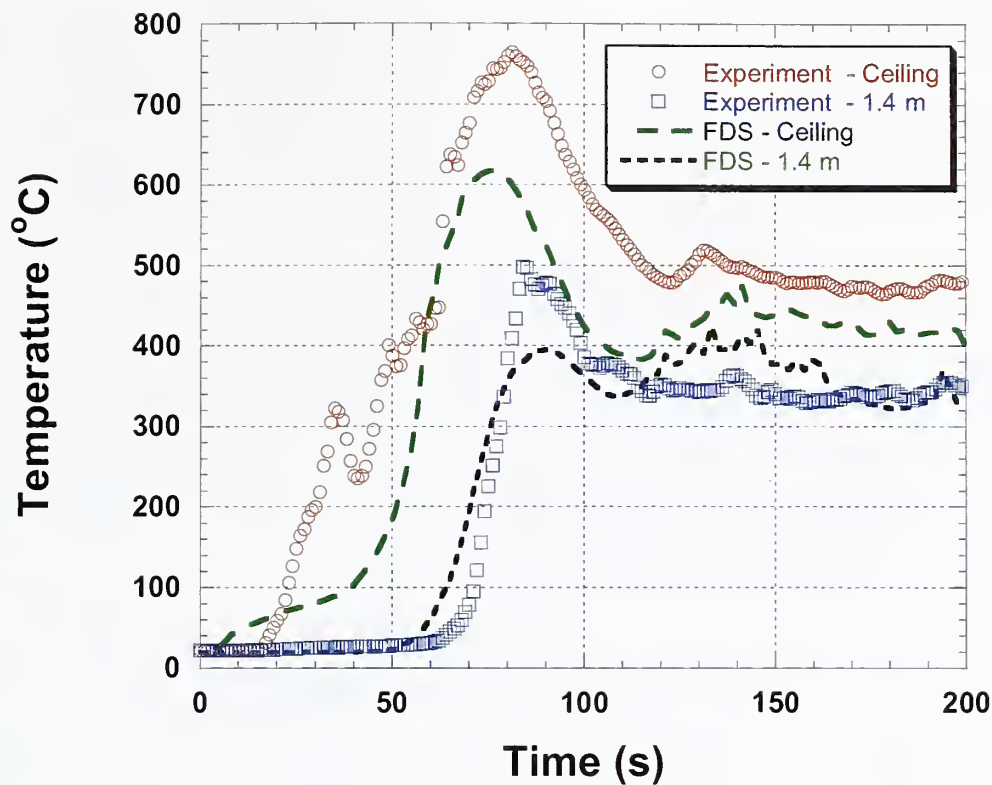
Figure 5-13. Temperature comparison between the un-sprinklered fire experiment and the FDS simulation at Station C.

Figure 5-13 is a comparison of the temperatures predicted and measured 25 mm below the ceiling and 1.4 m above the floor at the thermocouple array located at Station C (4.25 m west of the door opening or 1.7 m from the platform). The FDS output has been smoothed by applying a Stineman function (a geometric weight applied to the current point $\pm 10\%$ of the data range). The temperature data show reasonable agreement with the predictions, including an overshoot followed by a leveling off as the fire reaches a ventilation limit. The temperatures near the ceiling increase faster in the test; conversely, the lower level temperatures increase at a slower rate in the test.

Note that, unlike the heat release rate, the temperature measurements respond to the local environment within a second; hence, the experimental temperatures and FDS predictions can be compared directly. Initially, the experimental measurements near the ceiling increase more rapidly than predicted. This is probably due to the strong transverse temperature gradients associated with the ceiling jets created early in the fire (see Fig. 5-5), where small differences in position between the experiment and simulation can have a large change in temperature. The simulated thermocouple temperatures are temperatures averaged over the grid cell volume(s) that they are associated with, which results in differences in positions between the experimental point measurement and the FDS output. The peak temperatures for the experiment and the simulation occur within 5 seconds of each other.

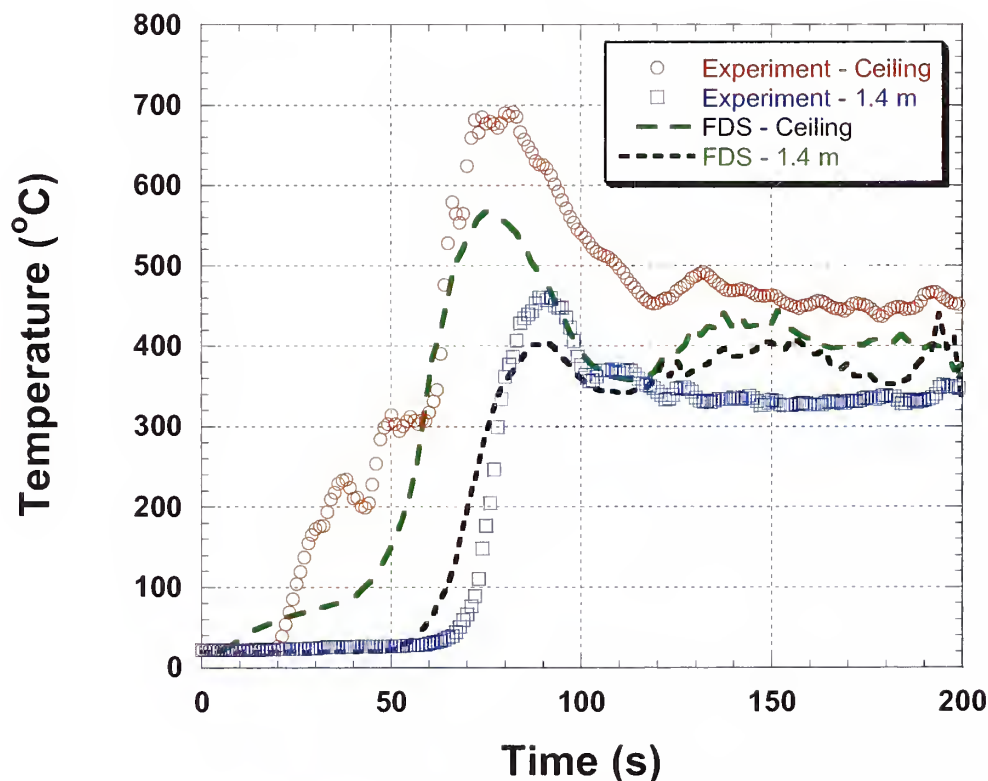
Figure 5-14. Temperature comparison between the un-sprinklered fire experiment and the FDS simulation at Station D.

Figure 5-14 is a comparison of the temperatures predicted and measured 25 mm below the ceiling and 1.4 m above the floor at the thermocouple array located at Station D (2.35 m west of the door opening). Similar to the previous figure, the temperature data show reasonable agreement with the predictions. The trends are also similar and both of the measured temperatures and the predictions exhibit a reduction in peak temperatures relative to the values from Station C that is located approximately 2 m closer to the platform.

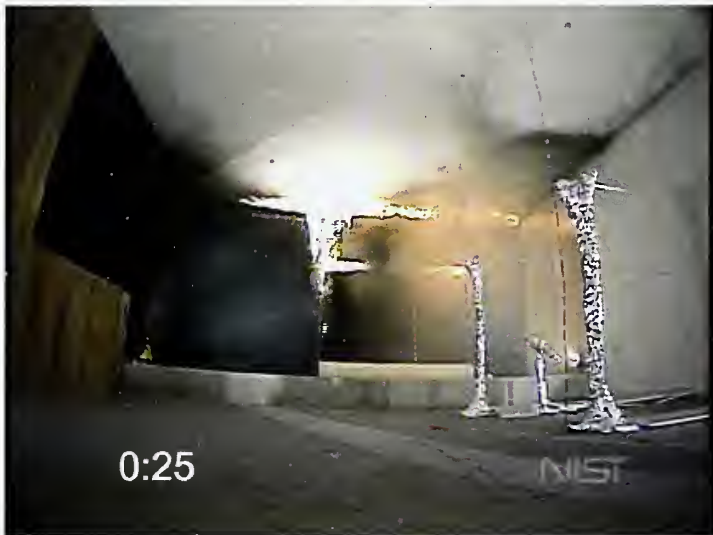
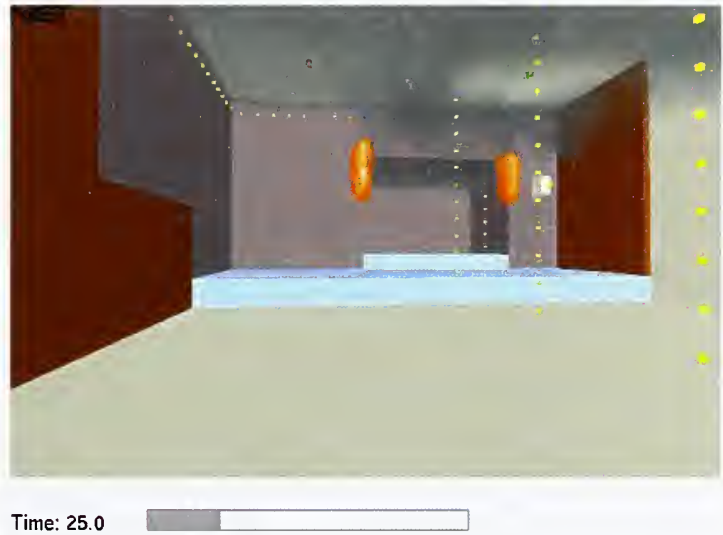
Figure 5-22. Initial sprinkler operating, $t = 25$ seconds after ignition.

sprinkler activation. Figures 5-19 through 5-21 show a very similar progression in fire growth as the unsprinklered case for both the experiment and the FDS simulation between ignition and 20 seconds after ignition. Figure 5-22 was captured at 25 seconds after ignition, approximately 1 second after the first sprinkler activated in both the experiment and the simulation. With the experiment, the impact of the sprinkler can be seen as the fire on the right side of the platform wall is suppressed. In FDS the flame height on the right side of the alcove can be seen to be reduced.

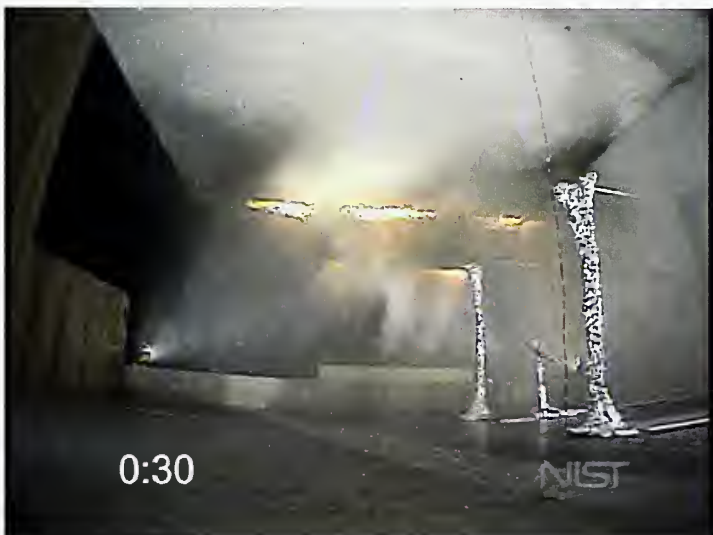
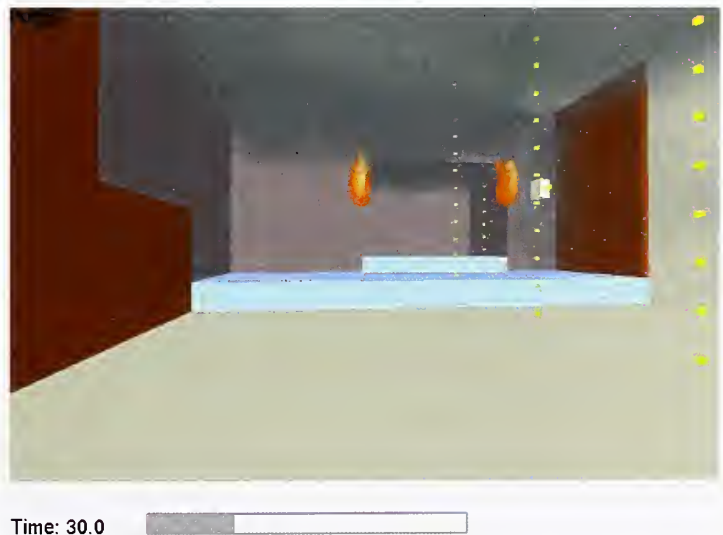
Figure 5-23. Third sprinkler operating in experiment, $t = 30$ seconds after ignition.

By 30 seconds (see Fig. 5-23) the effect of both of the sprinklers above the platform operating as well as the sprinkler in the alcove is apparent. Burning continues at the intersection of the platform wall and the ceiling. This area is above where the water spray is hitting the wall. Also notice the flames on the ceiling of the alcove. This area is shielded from the water spray of the two sprinklers. The smoke being pushed out of the alcove is due to the activation of the sprinkler on the ceiling of the alcove. In the simulation, only one sprinkler is operating at this time. The fire growth on the right side of the alcove has been limited by the single sprinkler.

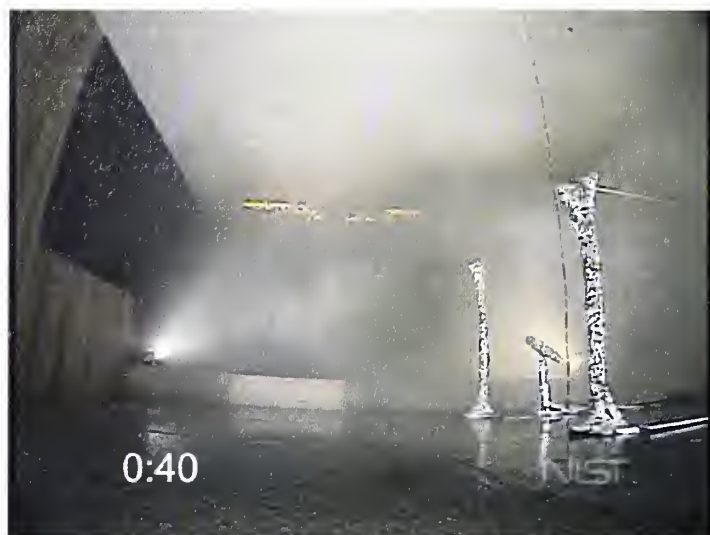
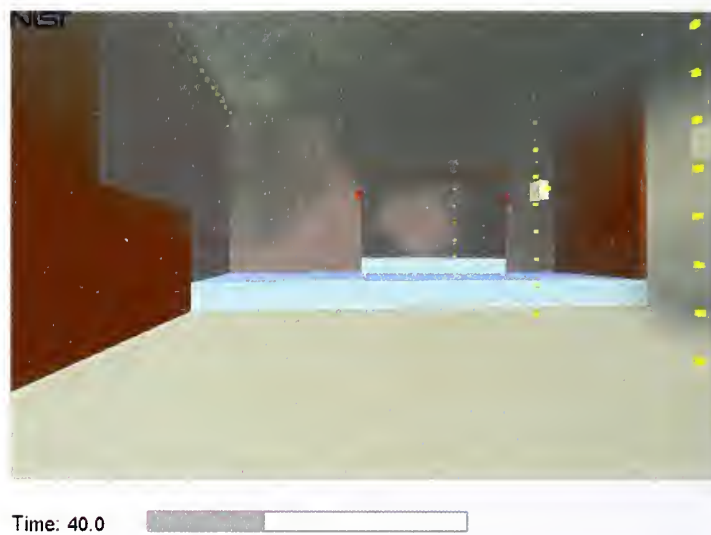
Figure 5-24. Suppression with three sprinklers operating in each case, $t = 40$ seconds after ignition.

By 40 seconds after ignition, three sprinklers in the experiment and in the simulation have activated. The video frame in Figure 5-24 shows that the fire in the alcove has been suppressed and that the burning above the water line on the platform wall continues. With three sprinklers operating in FDS, the water spray is significantly reducing the visible flames. The flames on the platform wall have been suppressed. However, there are still flames visible at the intersections of the alcove ceiling and the alcove walls on both sides of the alcove. These areas are shielded from the water spray of the sprinklers over the platform and they are above the water impact line from the sprinkler in the alcove.

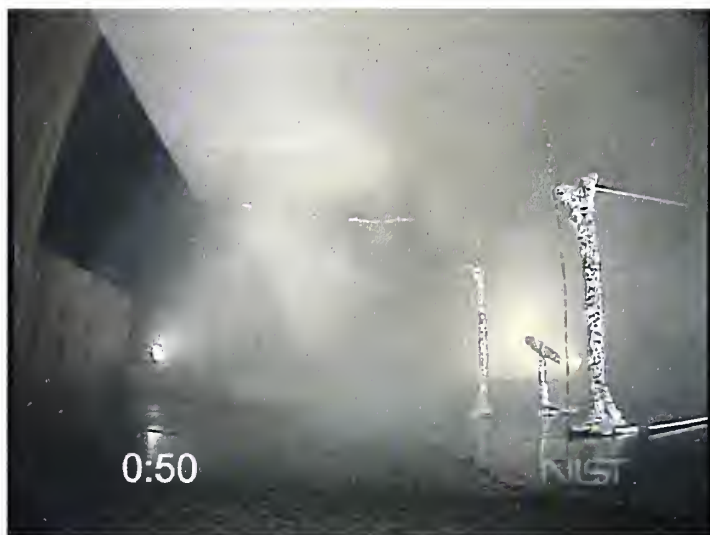
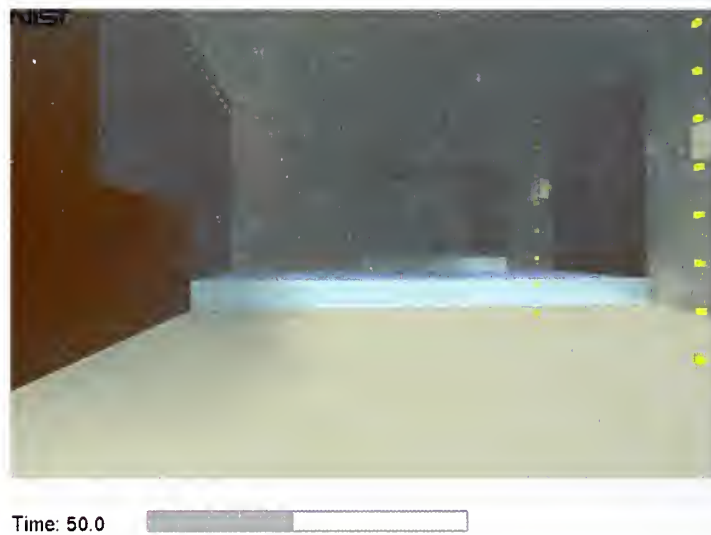
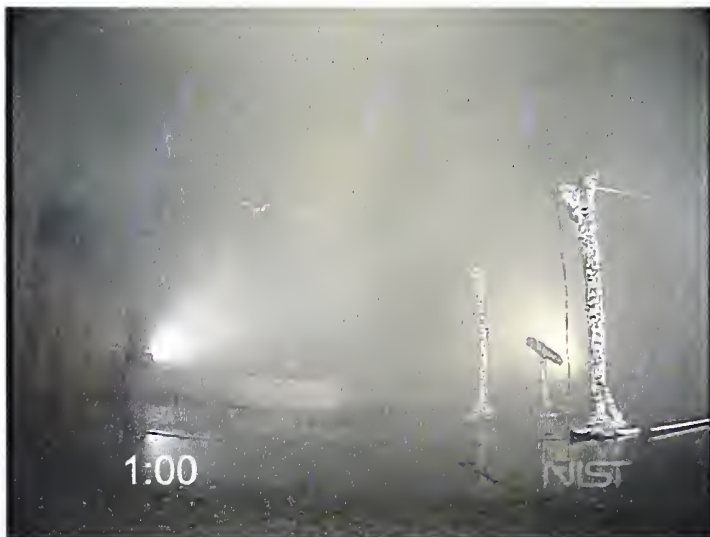
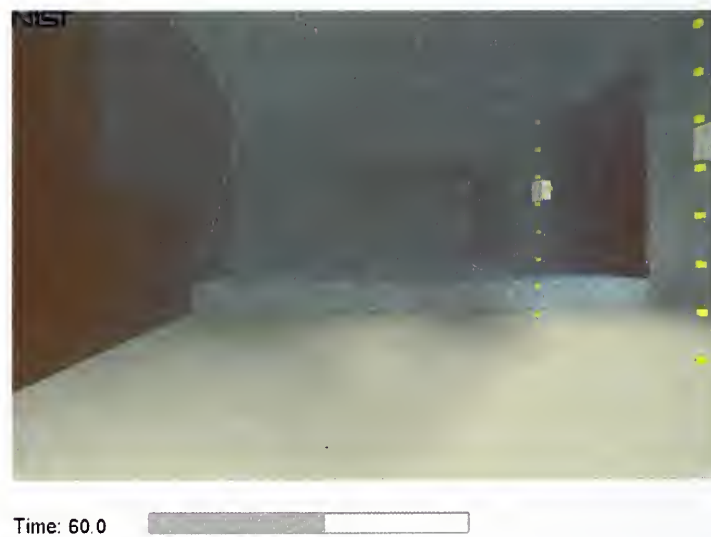
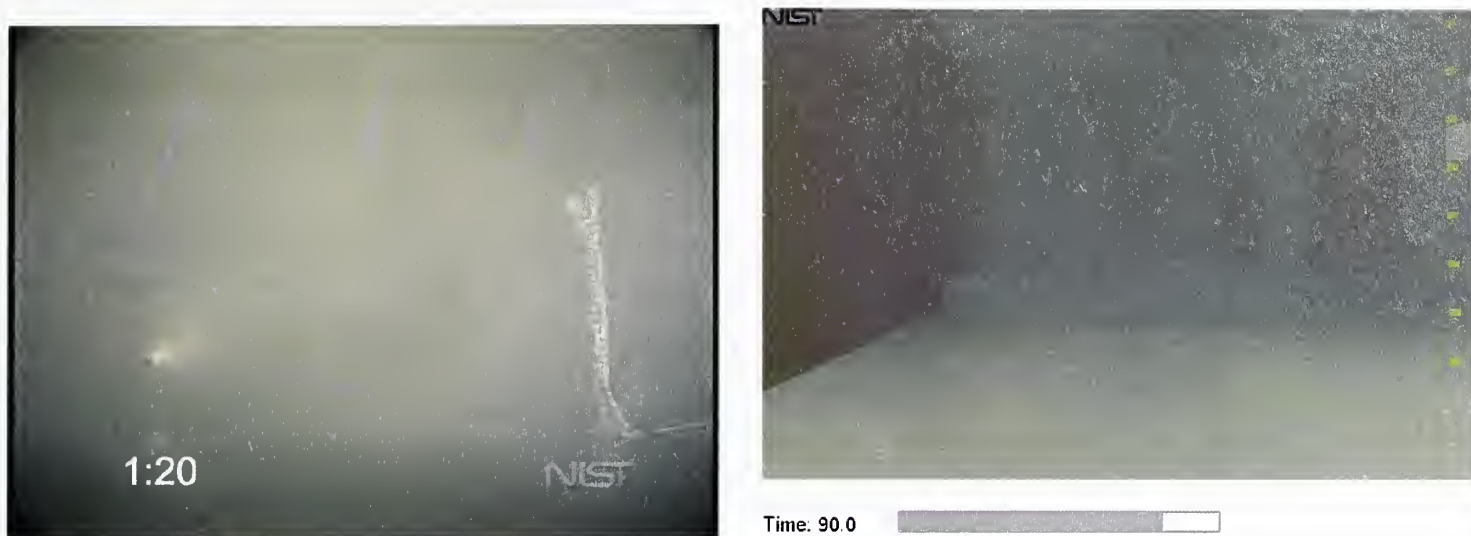
Figure 5-25. Fire suppression continues in both the experiment and the simulation, $t = 50$ seconds after ignition.

Figure 5-26. Fire controlled in both cases, $t = 60$ seconds after ignition.

Figure 5-27. Fire controlled in both cases, $t = 90$ seconds after ignition.

Figures 5-25 through 5-27 show continued fire suppression for both the experiment and the simulation. In both cases some flames exist in the ceiling area of the alcove. But clearly the rate of fire growth and the resulting hazard development has been reduced significantly when compared with the unsprinklered case.
